**NSWCCD-61-TR-2003/09**

Technical Report

**Spray Forming Iron Based Amorphous Metals**

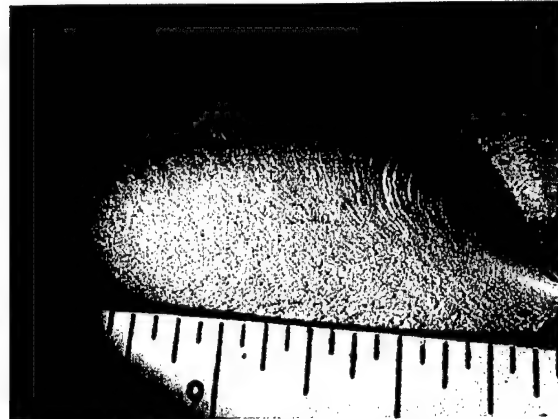
15a. Direct light, magnification 2x

15b. Indirect light, magnification 2x

**Figure 15. Optical Macrographs of Fracture Surface on Piece of As-sprayed DAR35 From Run 537. (The inch is the unit of the rulers in the photos).**

As previously mentioned, after each of the spray forming runs, the material cracked (Figures 4 and 5). Most of the fracture surfaces had a very brittle appearance without signs of any plasticity (Figure 14). However, the fracture surface (Figures 15 and 16) from Run 537, DAR35 had some signs of plasticity. It indicates the potential for this material to exhibit plasticity in mechanical property tests. Additional spray forming runs with DAR35 are planned, and the material will be used for tensile strength tests.

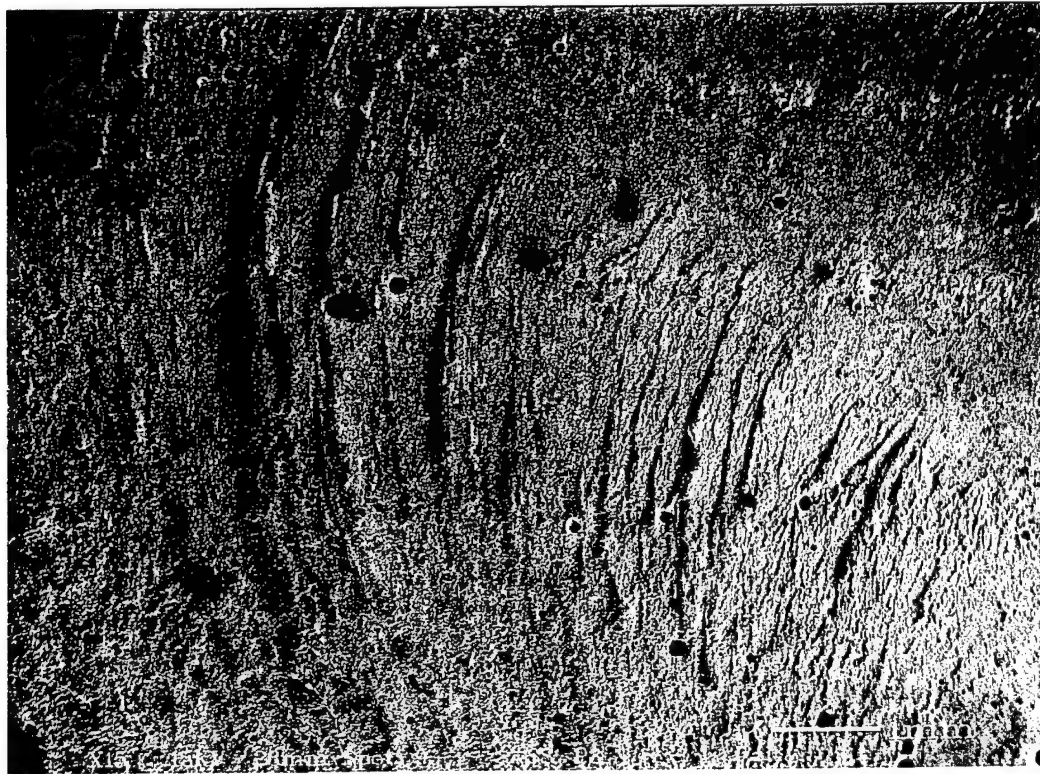
**Figure 16. Scanning Electron Microscope, Secondary Electron Image of Fracture Surface on Piece of As-sprayed DAR35 From Run 537.**
